**U.S. ENVIRONMENTAL PROTECTION AGENCY  
POLLUTION/SITUATION REPORT  
2015 Gold King Mine Release SITREP**

**Subject:** SITREP #4  
Gold King Mine Release

**San Juan County, Colorado**  
**Latitude: 37.8945 Longitude: -107.6384**

**From:** R8 IMT Situation Unit  
**Date:** 08/12/2015  
**Reporting Period:** 08/11/15 through 08/11/15  
**Website:** [epa.gov/goldkingmine](http://epa.gov/goldkingmine)

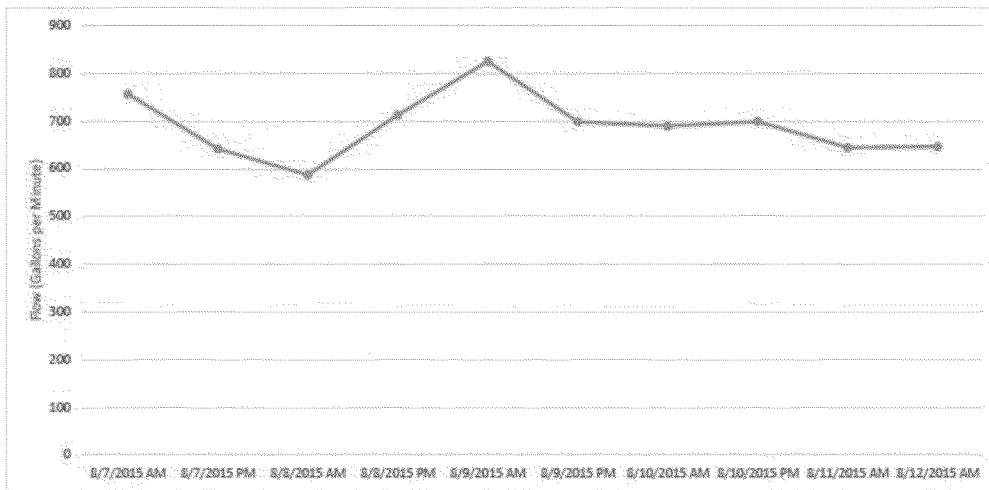
The EPA continues to operate four treatment and sedimentation ponds at the mine site which are treating water by lowering acidity levels and removing dissolved metals. Flow from the mine through the morning of 8/12/2015 is shown in the following chart.

Treated water from the last treatment pond is discharging into Cement Creek at levels cleaner (higher pH and lower levels of metals) than pre-event, background conditions in the creek. Over the next several days, the EPA will make upgrades to the system to ensure its continued operation. Flow data out of the mine is being collected manually two times per day. Water quality data is being collected at the influent and effluent of the treatment
